**Flood Control Project Maintenance  
Levee Inspections****LMA District Cover Sheet****Spring 2013 Levee Inspection Results****Reclamation District No. 0501 Ryer Island**

**Levee Inspection Report By Mile - Spring 2013**

**Reclamation District No. 0501 Ryer Island**

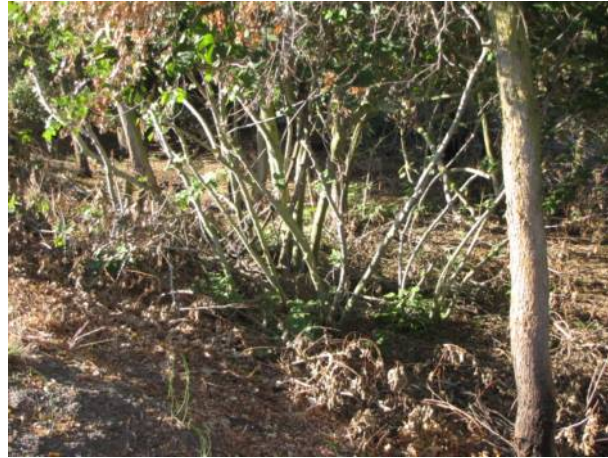
Levee Mile Report Line	8
Start Levee Mile	0.13
End Levee Mile	0.24
Location	Land Side
Category	
Item	Trim / Thin Trees

Levee mile 0.13: District need to remove the fig trees from levee section on the land side, not trim them up like shown in this photo. All these shown here are less than 2-inches in diameter.

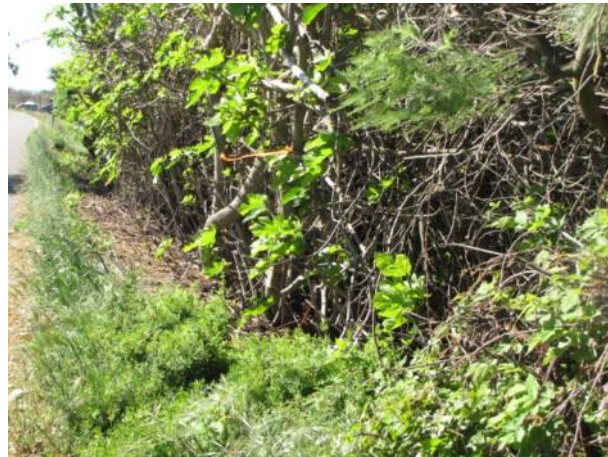
Levee Mile Report Line	10
Start Levee Mile	0.26
End Levee Mile	0.28
Location	Land Side
Category	
Item	Trim / Thin Trees

Unsatisfactory growth of fig trees that has the slope covered past the landward toe, unable to see the levee section. Photo taken 4-9-2013.

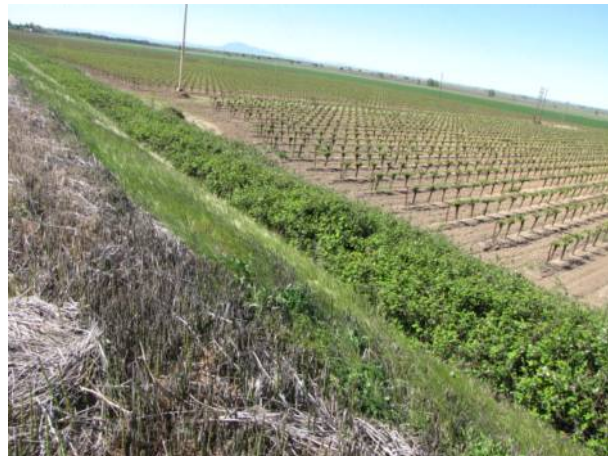
Levee Mile Report Line	19
Start Levee Mile	0.75
End Levee Mile	0.94
Location	Land Side
Category	
Item	Vegetation

Unsatisfactory growth of wild berries on landward slope and toe. Photo taken 4-9-2013.

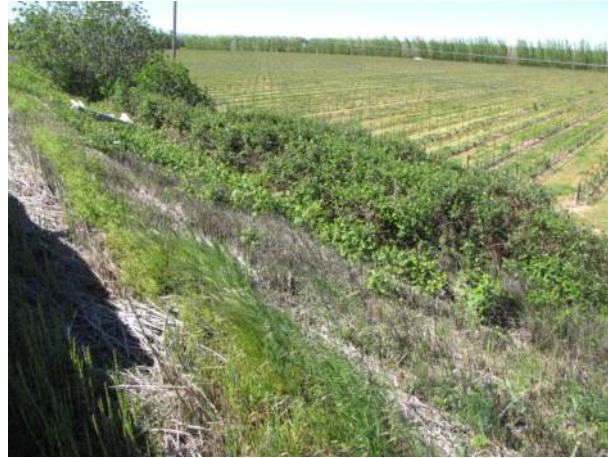
Levee Mile Report Line	23
Start Levee Mile	1.55
End Levee Mile	1.74
Location	Land Side
Category	
Item	Vegetation

Looking downstream landward slope and toe over grown with wild growth and berries and horsetail.

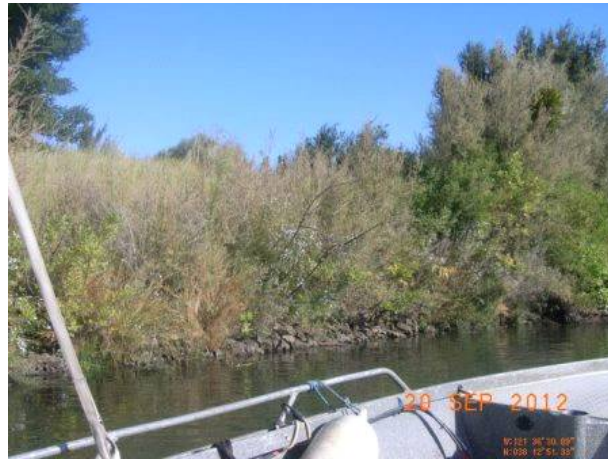
Levee Mile Report Line	32
Start Levee Mile	2.85
End Levee Mile	2.93
Location	Water Side
Category	Supplemental
Item	USACE Erosion Survey

USACE 2012 Photo #1

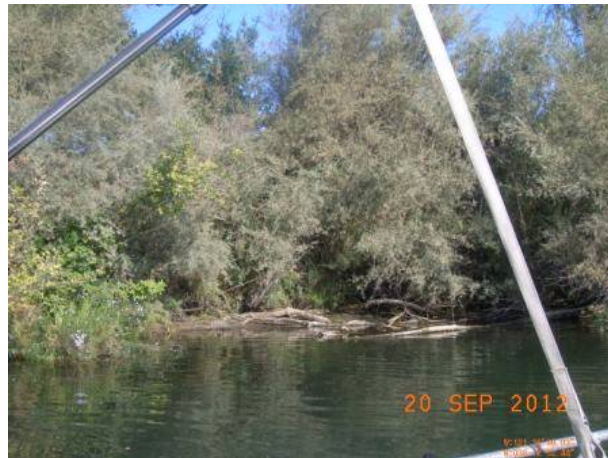
Levee Mile Report Line	32
Start Levee Mile	2.85
End Levee Mile	2.93
Location	Water Side
Category	Supplemental
Item	USACE Erosion Survey

USACE 2012 Photo #2

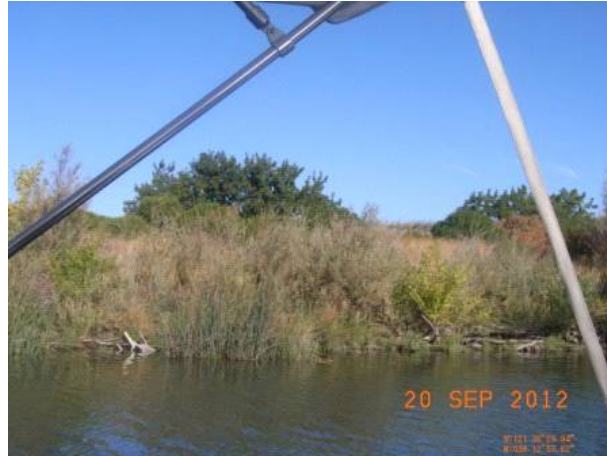
Levee Mile Report Line	32
Start Levee Mile	2.85
End Levee Mile	2.93
Location	Water Side
Category	Supplemental
Item	USACE Erosion Survey

USACE 2012 Photo #3

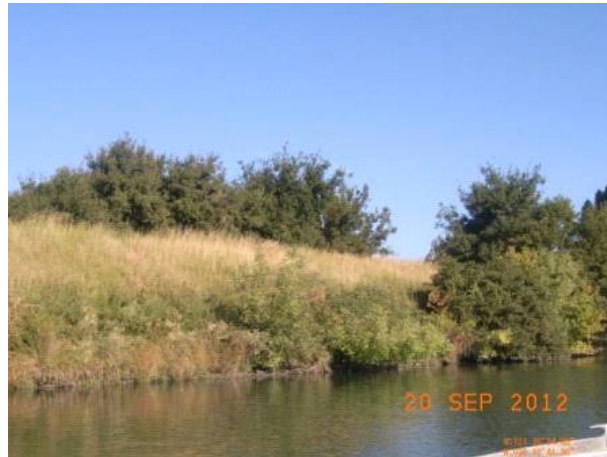
Levee Mile Report Line	34
Start Levee Mile	3.02
End Levee Mile	3.09
Location	Water Side
Category	Supplemental
Item	USACE Erosion Survey

USACE 2012 Photo #1

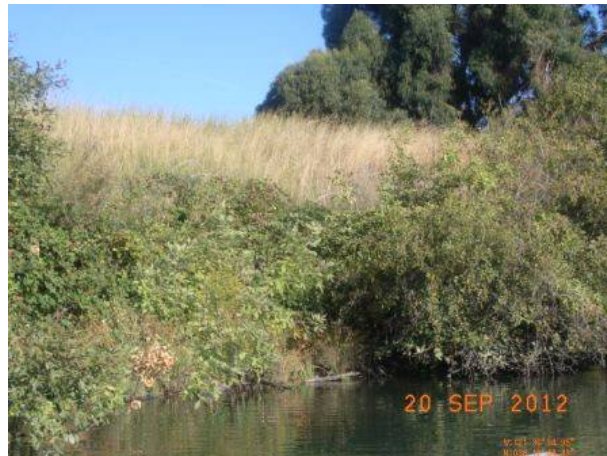
Levee Mile Report Line	34
Start Levee Mile	3.02
End Levee Mile	3.09
Location	Water Side
Category	Supplemental
Item	USACE Erosion Survey

USACE 2012 Photo #2

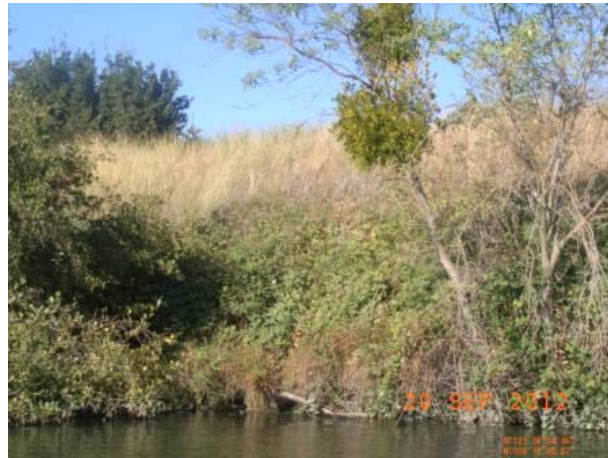
Levee Mile Report Line	34
Start Levee Mile	3.02
End Levee Mile	3.09
Location	Water Side
Category	Supplemental
Item	USACE Erosion Survey

USACE 2012 Photo #3

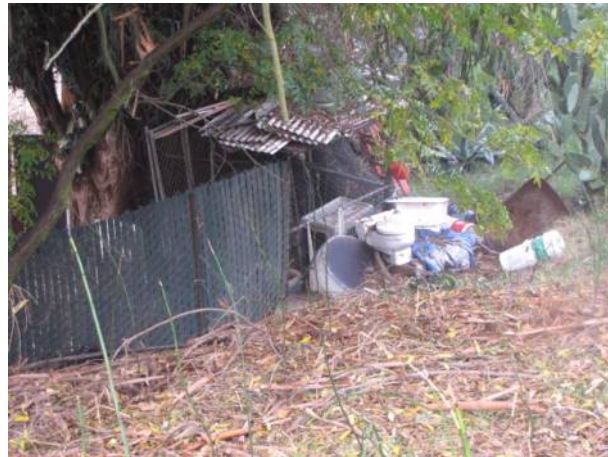
Levee Mile Report Line	36
Start Levee Mile	3.25
End Levee Mile	3.26
Location	Land Side
Category	
Item	Encroachments

RD 501, equipment and materials placed along the toe and slope landward looking back upstream. Photo taken 11-26-2012. No change during my inspection 4-9-2013. No new photo taken.

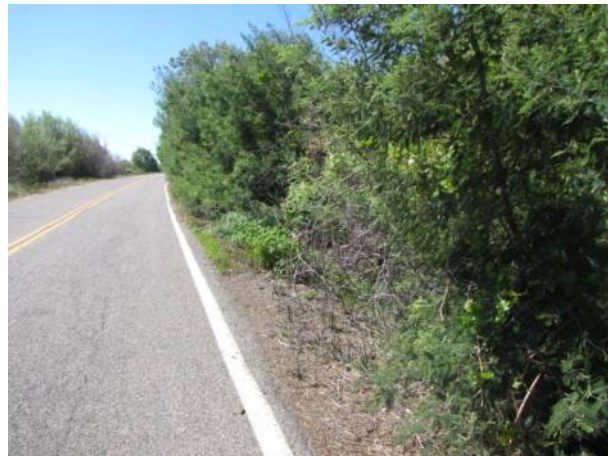
Levee Mile Report Line	38
Start Levee Mile	3.34
End Levee Mile	3.36
Location	Land Side
Category	
Item	Trim / Thin Trees

Unsatisfactory wild growth covering the landside slope, shoulder and slope. Photo taken 4-9-2013.

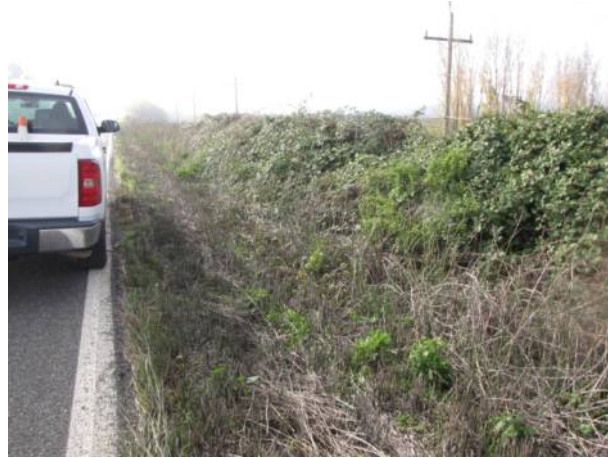
Levee Mile Report Line	45
Start Levee Mile	3.79
End Levee Mile	3.94
Location	Water Side
Category	
Item	Vegetation

RD 501, unsatisfactory wooded growth on landward slope and toe of levee section. Photo taken 11-26-2012.

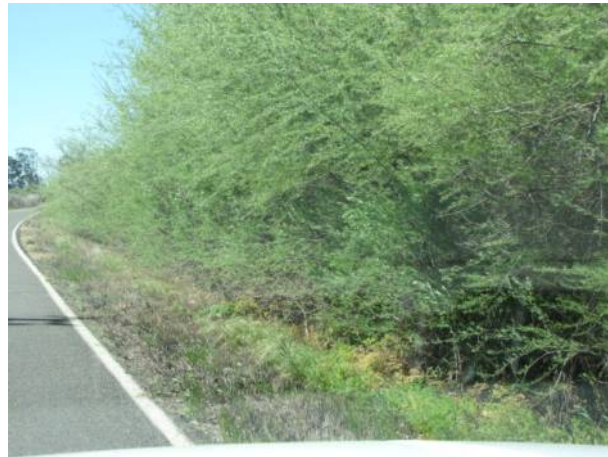
Levee Mile Report Line	46
Start Levee Mile	3.80
End Levee Mile	4.14
Location	Land Side
Category	
Item	Vegetation

Wild growth of trees blocking view of shoulder, slope and toe landward looking downstream. Photo taken 4-9-2013.

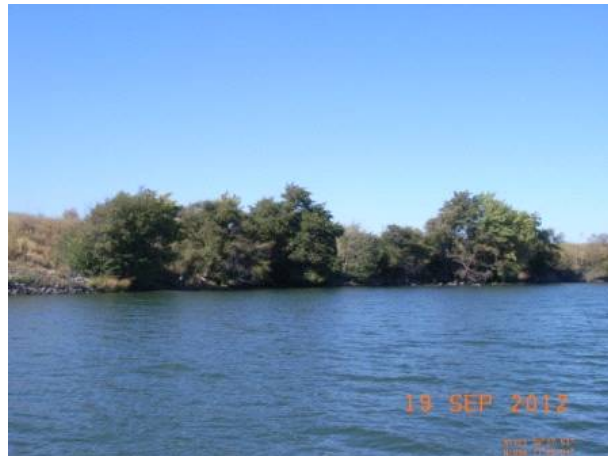
Levee Mile Report Line	57
Start Levee Mile	5.75
End Levee Mile	5.82
Location	Water Side
Category	Supplemental
Item	USACE Erosion Survey

USACE 2012 Photo #1

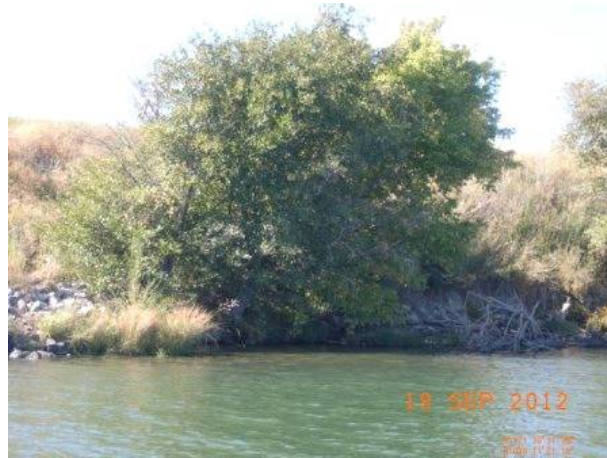
Levee Mile Report Line	57
Start Levee Mile	5.75
End Levee Mile	5.82
Location	Water Side
Category	Supplemental
Item	USACE Erosion Survey

USACE 2012 Photo #2

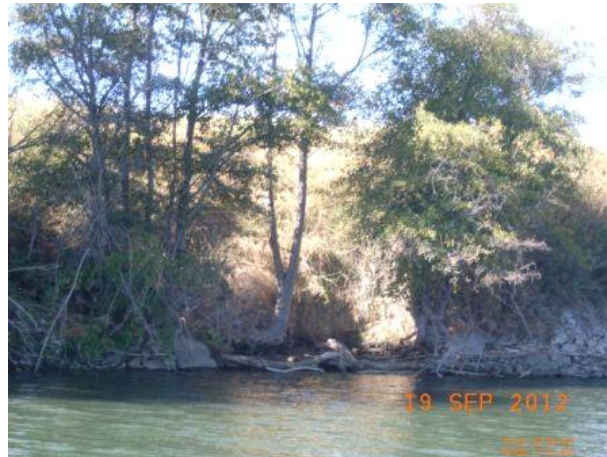
Levee Mile Report Line	57
Start Levee Mile	5.75
End Levee Mile	5.82
Location	Water Side
Category	Supplemental
Item	USACE Erosion Survey

USACE 2012 Photo #3

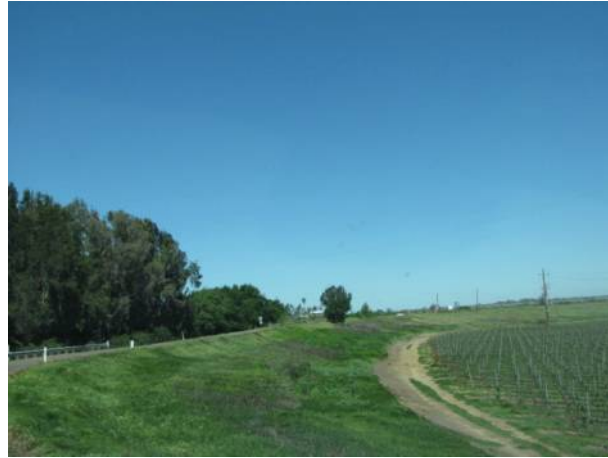
Looking downstream from levee mile 0.00 Unit 2 RD 501. Photo taken 4-29-13.

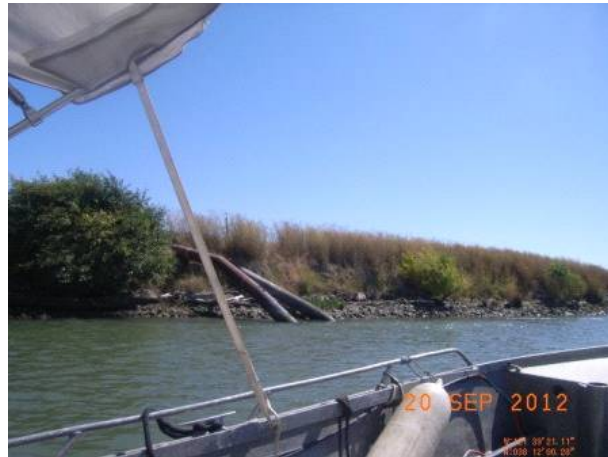
Levee Mile Report Line	12
Start Levee Mile	1.12
End Levee Mile	1.13
Location	Water Side
Category	Supplemental
Item	USACE Erosion Survey

LMR No.	Levee Mile		Category	Item	Location *	Rating **	Action/Comment	GPS Latitude/Longitude		Issue No. Photo
	Start	End						Start	End	
12	1.12	1.13	Supplemental	USACE Erosion Survey	WS	M Ma	Inspector Comments: 2005 - Large vertical sections due to wave wash. New stone dumped on the bank with exposed geotextile. Cohesive toe has thin weak stratigraphic unit that is washing out. 2006 - Partially repaired, but 100 ft in the middle of the reach has exposed filter fabric and stone riprap is gone. 2010 - Site extended downstream to include new erosion pocket. 2012: No observed change, channel marker 42. [2012 Site ID: CHS_15-9_L]	38.200146 ° -121.655638 °	38.199128 ° -121.655881 °	6 Y
DWR ID: DWR_RD0501_02_s_2013_6										
13	1.51	2.69		Vegetation	LS	M Ma	V2 : Remove the wild growth other than native grasses from the levee slopes.	38.204957 ° -121.655087 °	38.216130 ° -121.667686 °	1
DWR ID: DWR_RD0501_02_f_2012_1

USACE 2012 Photo #1

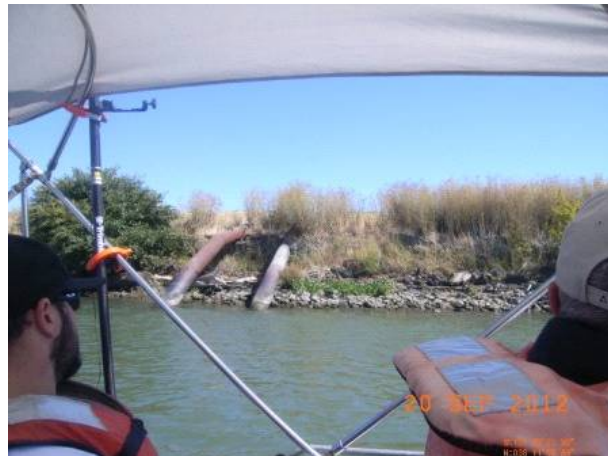
Levee Mile Report Line	12
Start Levee Mile	1.12
End Levee Mile	1.13
Location	Water Side
Category	Supplemental
Item	USACE Erosion Survey

USACE 2012 Photo #2

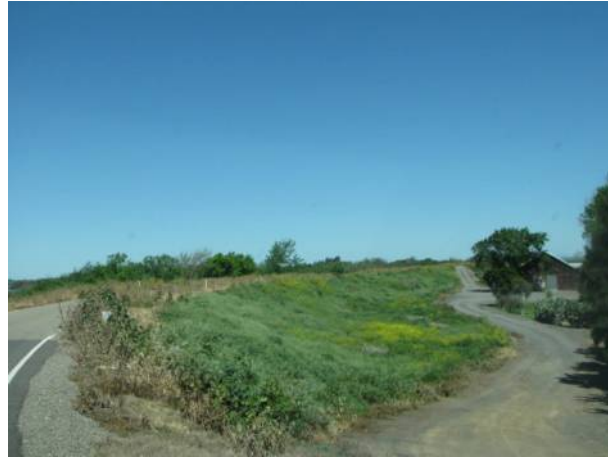
Looking downstream from land side levee minle 0.00 Unit 3. Photo taken 4-9-2013.

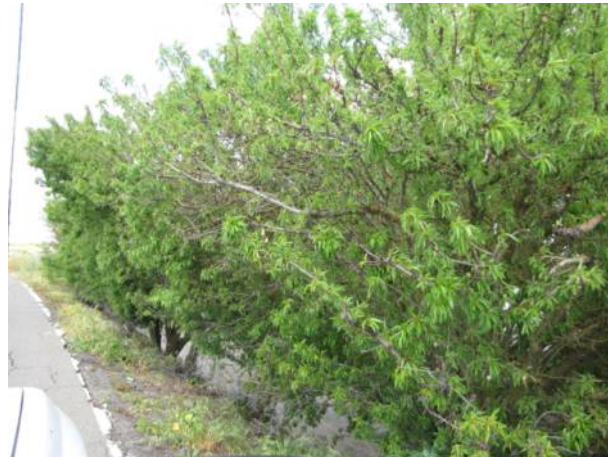
Levee Mile Report Line	15
Start Levee Mile	3.69
End Levee Mile	3.70
Location	Land Side
Category	
Item	Trim / Thin Trees

Levee mile 3.69 to 3.70, new photo of the unsatisfactory growth on the landside levee slope. Photo taken 4-19-11.

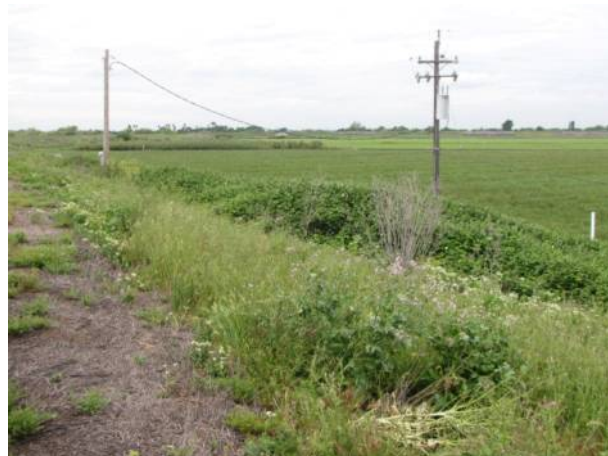
Levee Mile Report Line	17
Start Levee Mile	3.79
End Levee Mile	4.82
Location	Land Side
Category	
Item	Vegetation

Looking downstream from landside unsatisfactory growth of wild berries on slope and toe. Photo taken 4-25-2012.

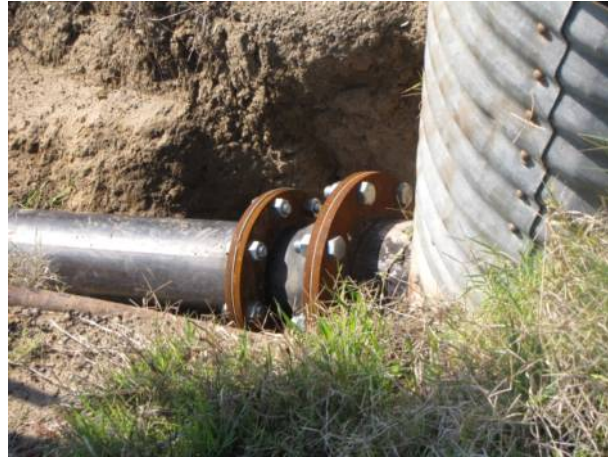
Levee Mile Report Line	25
Start Levee Mile	7.35
End Levee Mile	7.35
Location	Land Side
Category	
Item	Encroachments
RD 501 Unit 3 levee mile 7.34 unauthorized pipe, open trench on water side levee toe. Photo taken 11-26-2012. There is no change at this site 4-9-2013.	
phillips_s_20130228_145.jpg

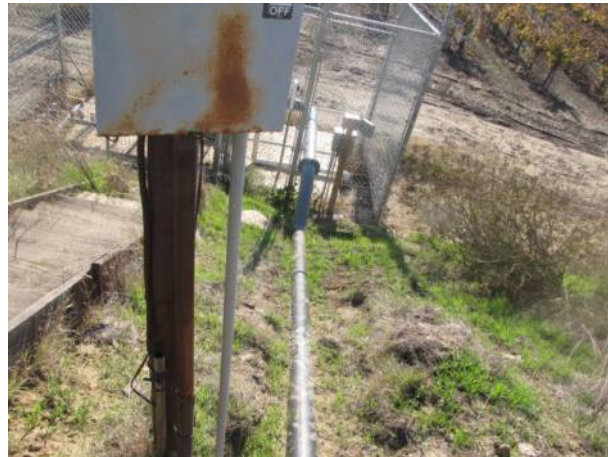
Levee Mile Report Line	25
Start Levee Mile	7.35
End Levee Mile	7.35
Location	Land Side
Category	
Item	Encroachments
Unauthorized pipe, 11-26-2012.	
phillips_s_20130228_146.jpg

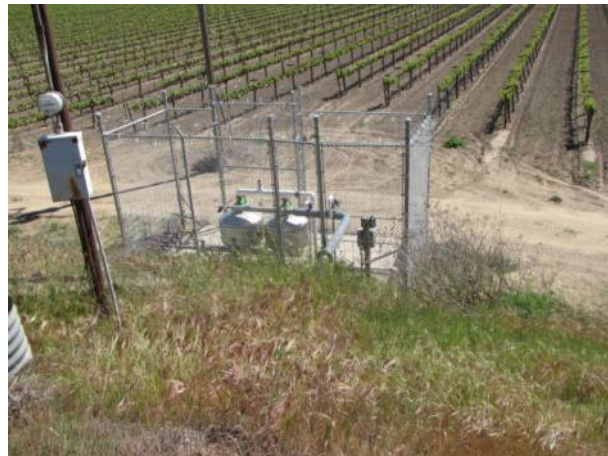
Levee Mile Report Line	25
Start Levee Mile	7.35
End Levee Mile	7.35
Location	Land Side
Category	
Item	Encroachments
This encroachment still remains unresolved, no permit for this structure. Photo taken 4-9-2013.	
phillips_s_20130604_461.JPG

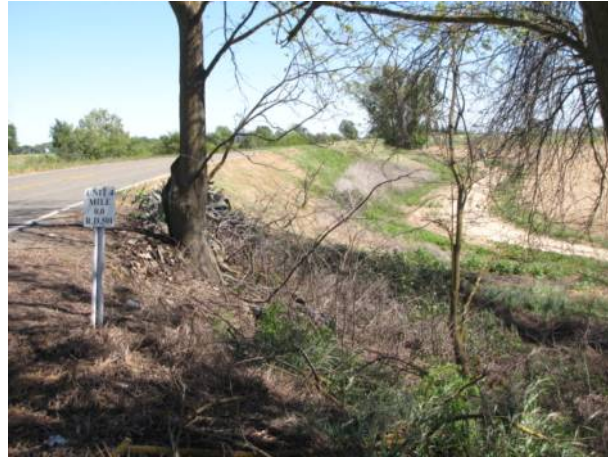
Levee Mile Report Line	1
Start Levee Mile	0.00
End Levee Mile	0.00
Location	Land Side
Category	
Item	Vegetation
Unit 4 RD 501 Levee mile 0.00 looking downstream from landside shoulder. Photo taken 4-9-2013.	
phillips_s_20130604_463.JPG

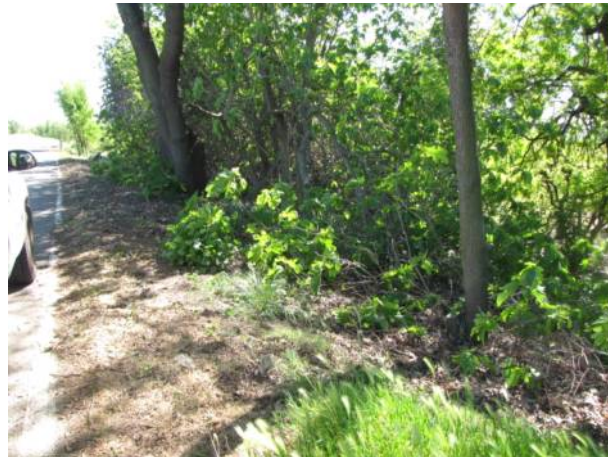
Levee Mile Report Line	10
Start Levee Mile	1.84
End Levee Mile	1.87
Location	Land Side
Category	
Item	Trim / Thin Trees
There has been some tree cutting at this location growth continues to block view of levee section. Photo taken 4-9-2013.	
phillips_s_20130604_464.JPG
